NWQEP NOTES

Number 131

March 2009

The Use of Aquatic Insects to Assess the Effectiveness of Stream Restoration in North Carolina

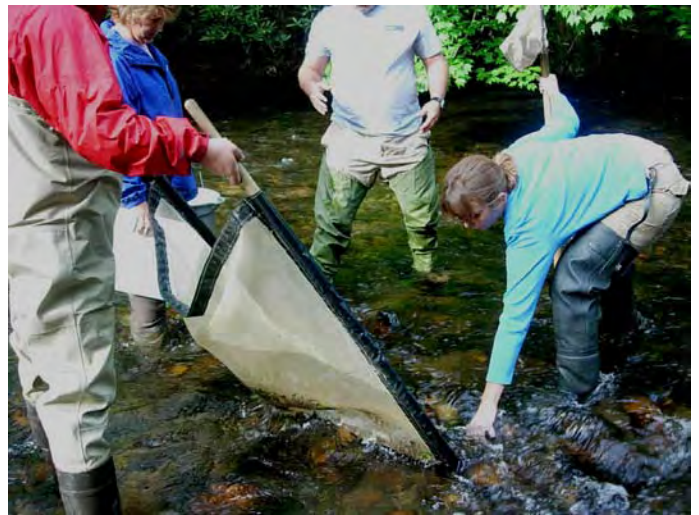
Figure 2. Kick net sampling.

There are numerous standard approaches to collection of benthic macroinvertebrates, including dip netting, kick seining (Figure 2), Surber sampling, and artificial substrates. All of these methods strive to collect a representative and reproducible sample of organisms living in the aquatic system. The North Carolina Division of Water Quality (NC DWQ) has successfully employed a semi-quantitative, multi-habitat collection technique in its monitoring programs. Survey protocols for stream restoration monitoring, including sample collection and processing, mimic those described in the Standard Operating Procedure of the Biological Assessment Unit of NC DWQ (NCDEHNR 1997). Copies of this document can be obtained from NC DWQ's website (<http://www.esb.enr.state.nc.us/BAU.html>).

Standard qualitative collection methods are recommended for surveys conducted in all streams that are 3rd order or larger. This collection method consists of two kick net samples, three sweep net samples, one leaf-pack sample, two fine-mesh rock and/or log wash samples, one sand sample, and visual collections (Lenat 1988). Insects are separated from the rest of the sample in the field ("picked") using forceps and white plastic trays, and preserved in glass vials containing 95% ethanol. Organisms are picked roughly in proportion to their abundance, but no attempt is made to remove all organisms from the samples. If an organism can be reliably identified as a single taxon in the field (e.g., *Isonychia*, see Figure 1), then no more than 10 individuals need to be collected. The primary output for this collection technique is a taxa list with a relative abundance (Rare, Common or Abundant) for each taxon.

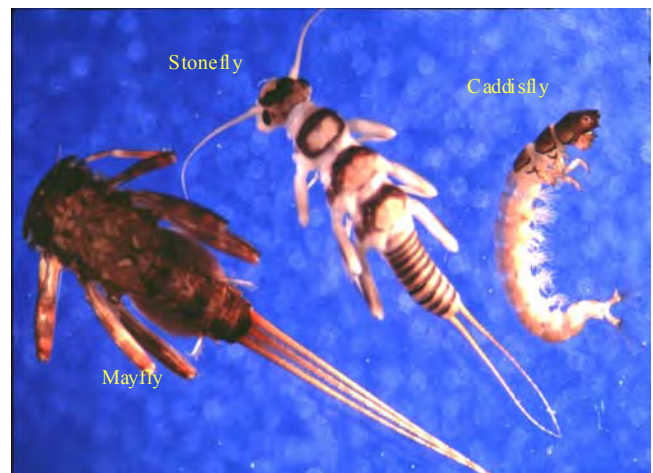
Figure 3. Ephemeroptera, Plecoptera and Trichoptera (EPT).

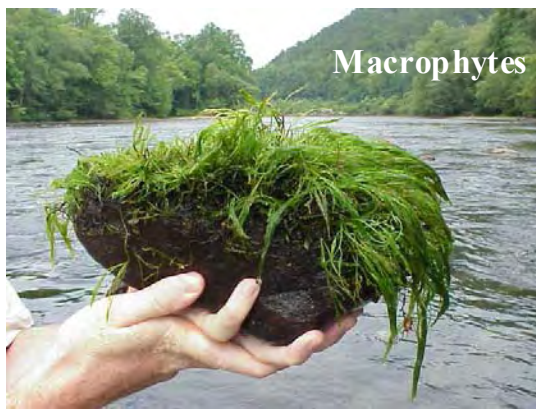
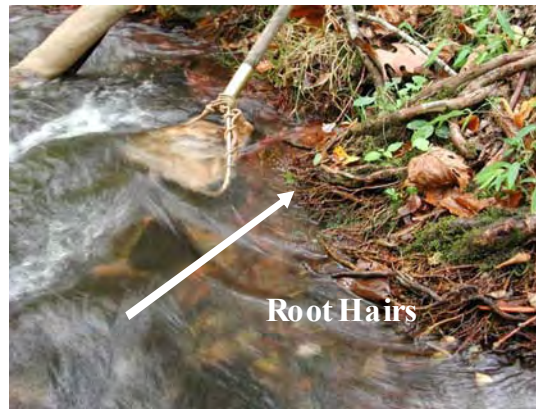
Figure 4. Common microhabitats found in healthy streams.

As work continues with the development of success criteria, the development of microhabitats and their resident biota should be investigated. Figure 4 illustrates two productive microhabitat types (aquatic macrophytes and streamside root hairs) that should develop as streams mature and resident fauna become more abundant.

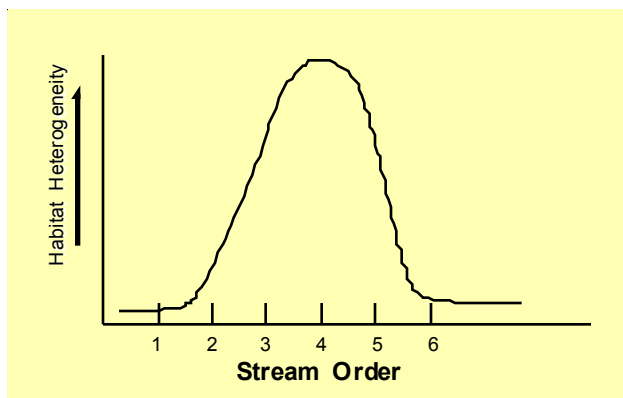
Figure 6. Habitat heterogeneity and stream order.

Stream Size Variability. To the extent possible, data should be compared only from similar sized stream reaches. The **river continuum concept** (Vannote et al. 1980, Minshall et al. 1985) predicts that habitat heterogeneity increases with stream size to approximately 4th order streams and then declines (Figure 6). The river continuum concept predicts that a stream ecosystem is comprised of a series of biological communities that merge into one another as the biota respond to changing in-stream physical/habitat and riparian conditions. Therefore, it is expected that as habitat heterogeneity increases, the potential diversity of the resident benthic community would increase as well and then decline as streams become much larger. Care should be taken not to compare data from streams of different orders, particularly when using data for reference conditions.

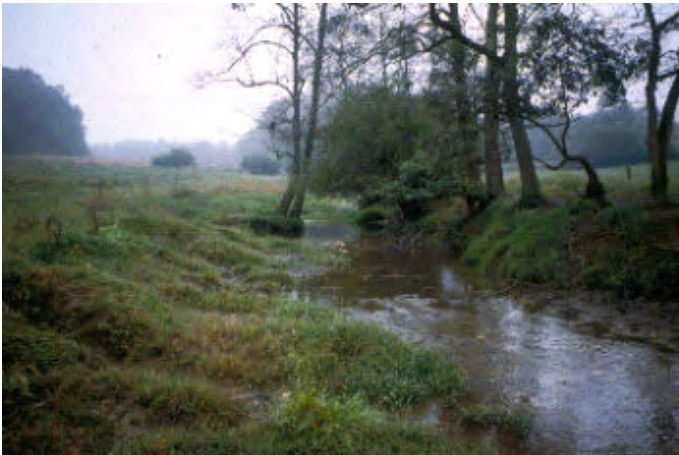
Figure 9. Jumping Run Creek prior to restoration activities – 2000.

Station 2 is located within the restored reach of Jumping Run Creek. Prior to construction, the stream was very unstable at this point and cattle had free access (Figure 9). Sand and silt dominated the substrate, bank erosion was severe and the tree canopy had been reduced or eliminated in some places. Furthermore, it appeared that this reach of Jumping Run Creek had been channelized in the past. As part of this project, herbaceous vegetation was planted in the new riparian buffer.

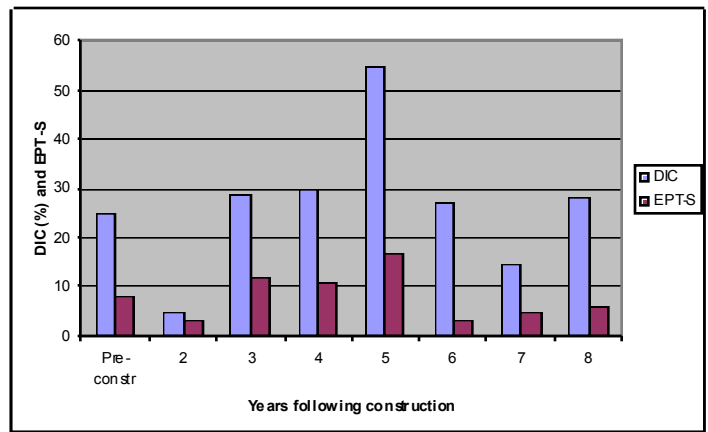
Figure 10. Dominant in Common (%) and EPT taxa richness from Station 2, in the restored reach of Jumping Run Creek (2000-2008).

Taxa richness and EPT abundance values from the upstream reference site (Table 1a) indicate relatively stable conditions and a surprising number of intolerant (indicator) species over the monitoring period (21 indicator taxa were collected from this site in 2005). However, the number of EPT taxa dropped off significantly in 2007 and 2008. This trend may have been due to very low flow conditions due to the drought, or upstream impacts. Many of these intolerant taxa were completely eliminated downstream of this location prior to construction and replaced by tolerant filter-feeding taxa, presumably responding to the input of fine particulate organic matter from the pasture prior to construction. Dominant in Common percentages of 25% at both downstream locations prior to restoration suggest that some intervention and/or restoration were necessary (Figures 10 and 11).

During the first investigation following construction (2002), the number of taxa and EPT abundance values declined dramatically at Station 2 within the restoration reach and then rebounded through the third, fourth and fifth years following construction with a DIC of 55% in 2005 (Figure 10). However, these numbers declined in years six through eight following construction (2006-2008) with EPT taxa richness very similar to the first post-construction survey in 2002. Many taxa were common or abundant at the upstream reference and at the downstream recovery site during the course of this investigation, but absent in the restored reach (e.g., *Stenonema pudicum*, *Baetis pluto*, *Neophylax*, *Eccoptura xanthenes*).

Taxa richness and DIC values are similar to pre-construction data at Station 2, suggesting that in-stream habitat conditions and the benthic fauna within this reach have not improved during this 7-year monitoring period. One issue is that this reach of Jumping Run Creek is dominated by a series of large cross vanes that were constructed during the restoration process. These large cross vanes have produced very long pools and very short, unproductive riffles. These habitats are not conducive to the establishment of a diverse benthic fauna and resulted in very low DIC values following construction. In addition, beaver populations have been noted in the catchment, although not at Station 2 specifically.

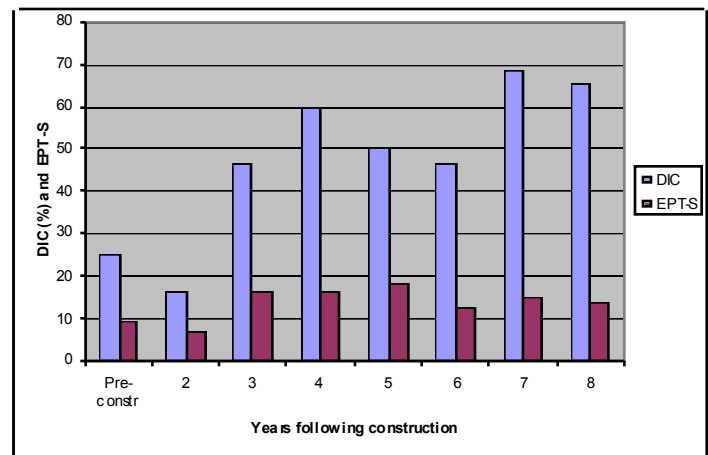
Figure 11. Dominant in Common (%) and EPT taxa richness from Station 3, in the recovery location of Jumping Run Creek (2000-2008).

However, benthic data from the recovery site on Jumping Run Creek (Station 3) clearly indicate an improvement in biological conditions (Figure 11). Very low DIC numbers were recorded prior to construction and during the first collection following construction (2002). However, these DIC values and the number of EPT taxa increased during year 3 and have remained high during all subsequent investigations. These data suggest that the restoration work on Jumping Run Creek has improved the water quality and biological condition of the stream below the construction reach. The explanation for a biological response **downstream** of the restored reach is unclear. The replanted riparian zone in the restored reach may have reduced downstream nutrient and sediment concentrations, resulting in a positive response from the benthic community.

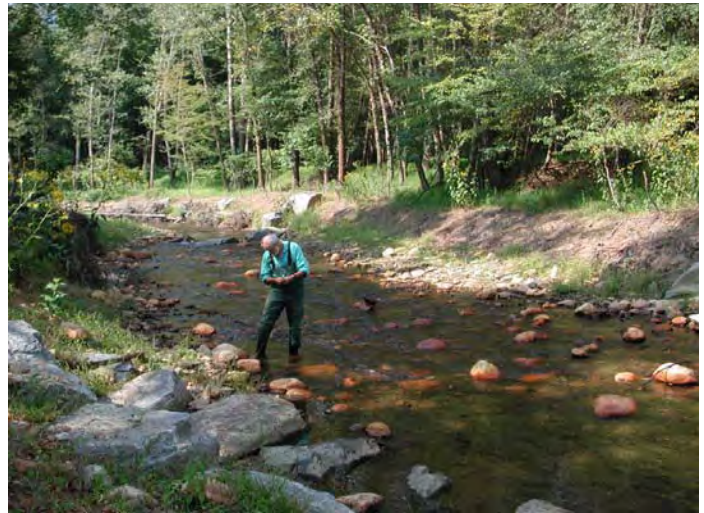
Figure 14. East Prong of the Roaring River, Stone Mountain State Park.

Stone Mountain State Park (Wilkes County, NC). Studies indicated that downstream reaches of the East Prong of the Roaring River (Figure 14) in Stone Mountain State Park had severe bank erosion due to past agricultural practices. Restoration of the East Prong in 2000 included stabilizing the eroding banks, providing in-stream habitat, and reestablishing

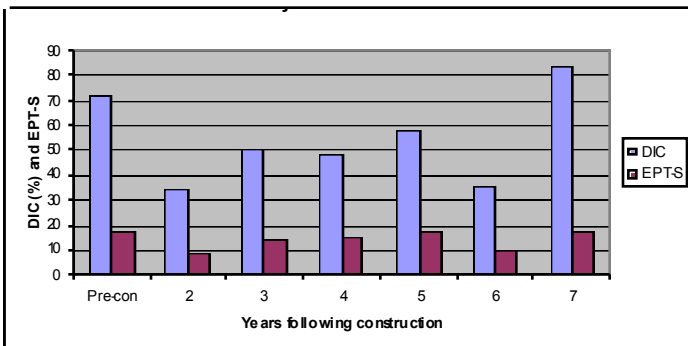
Figure 13. Dominant in Common (%) and EPT taxa richness from Station 2, in the restored reach of UT Lyle Creek (2001-2008).

The benthic macroinvertebrate community at the reference reach has been variable between monitoring years. Taxa richness values (both total and EPT numbers) were much lower at the reference site in 2004 and 2007 (Table 2). These lower numbers may be a response to scour associated with extremely high flows following hurricanes Ivan and Francis in September 2004 and perhaps much lower flows during drought conditions in 2007. Interestingly, the extremely high flows in 2004 (three years following construction on Figure 13) did not appear to affect recovery of the restored reach as both DIC and EPT taxa richness increased. However, very low flows in 2007 (six years following construction) may have been partially responsible for much lower DIC and EPT taxa richness values at the restored reach. Prior to 2007 it appeared that a general trend towards recovery was noted in the restored reach. The benthic fauna rebounded in 2008 as all metrics increased and the DIC value attained the preliminary success criteria initially proposed to the U.S. EPA (NCDENR 2002).

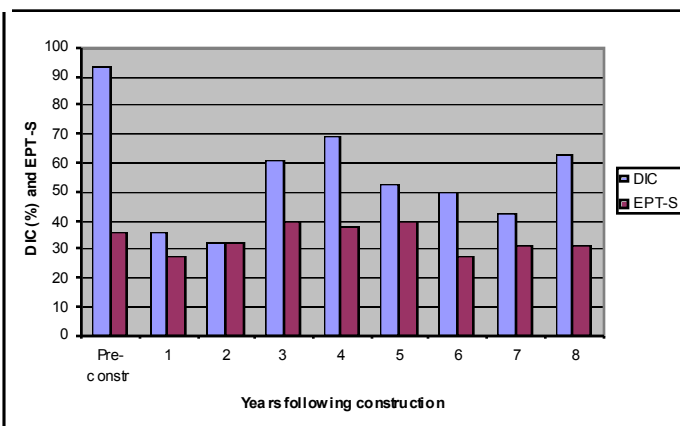
Figure 17. Dominant in Common (%) and EPT tax richness from Station 3, within the lower restored reach of the East Prong of the Roaring River, Stone Mt State Park.

The biological fauna at the lower site within the restored reach (Station 3) appear to be much more variable than the upstream location. Lower EPT taxa richness, abundance and DIC values were noted throughout the monitoring period following restoration at Station 3. A surprisingly large number of EPT taxa were collected from this reach in 2003 and 2004 following construction, suggesting that water quality conditions were good and that the stream is recovering from stress associated with the restoration. However, the number of taxa in common with the reference reach (DIC) declined significantly in 2006 and 2007, six and seven years following construction. Differences in taxa richness between these two sites were due to the much lower numbers of caddisfly and stonefly taxa. Mayfly taxa have been extremely high at this location during all surveys (range = 16-21 taxa). Most mayfly taxa are proficient drifters and can repopulate newly restored reaches faster than stoneflies (which are either predaceous or shredder taxa) or caddisflies. The much lower numbers of stoneflies and caddisflies are most obvious during surveys conducted in 2001/2002 immediately following restoration and 2006/2007 (six and seven years following construction). The loss of many taxa within these two groups is primarily responsible for much lower DIC comparisons noted during these two periods. It is very likely that the lowered DIC values in 2001/2002 are directly related to restoration activities in this reach. Recovery appeared to be occurring during 2003 and 2004, but a reversal in this positive trend was observed in 2006 and 2007 possibly related to project maintenance

activities that began in 2005. Maintenance included rebuilding some of the cross vanes and re-establishing stable banks, both of which had failed during the monitoring period.

Biological data from this project indicate that restoration at the lower reach was not successful, given the 8-year monitoring period. As noted above, the maintenance activities may have re-introduced some instability. Or perhaps a monitoring period longer than eight years is needed to show recovery. It is also important to note that perhaps because the stream was relatively healthy and stable to begin with, it may not have been an appropriate candidate for the level of restoration that was conducted, and that less invasive work or spot repairs on severely eroding banks may have been all that was necessary.
