Oklahoma

**Peacheater Creek
Section 319
National Monitoring Program Project**

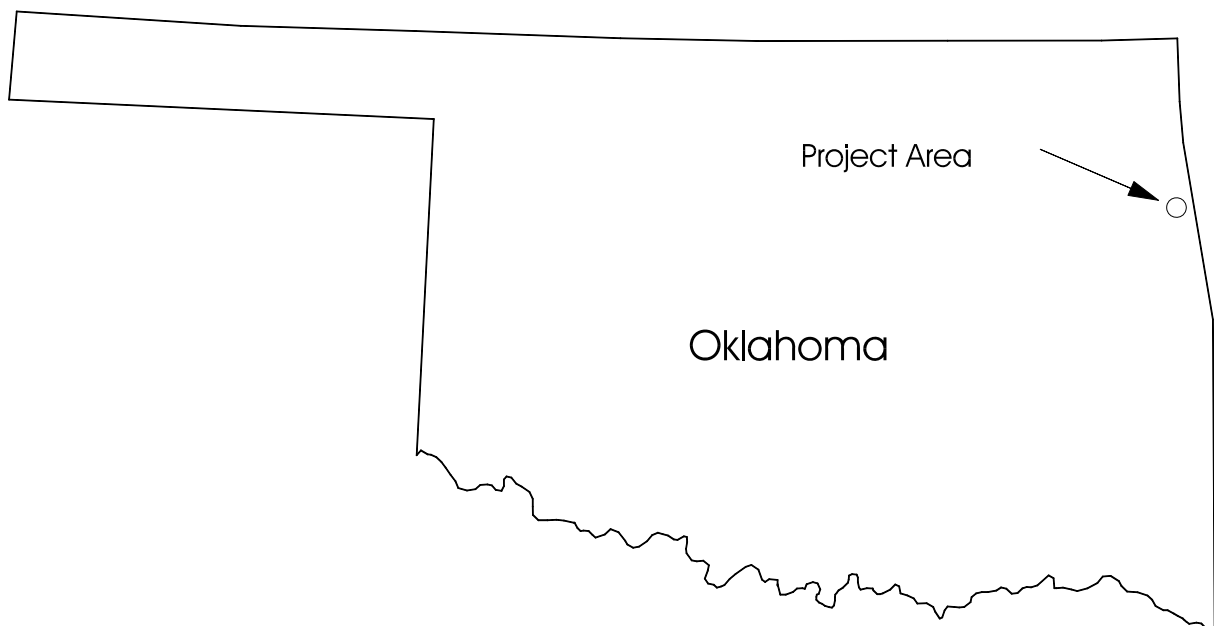
Figure 34: Peacheater Creek (Oklahoma) Project Location

Peacheater Creek is located in eastern Oklahoma (Figure 34). The watershed is primarily pastureland and forestland with little cropland or rangeland. There are 65 poultry houses (locations of complexes or single houses shown in Figure 35), four dairies, and numerous beef cattle producers in the watershed. Cattle traffic and forestry activities are known to be major contributors to streambank erosion. Streambank erosion was quantified to estimate loads of sediment, total nitrogen, and total phosphorus contributed to each stream. Large gravel bars generated from streambank erosion impair fish and macroinvertebrate habitat quality. Baseflow monitoring shows intermittent high nutrient levels contribute to creek eutrophication. Impacts downstream of Peacheater Creek include streambank erosion, habitat degradation, nuisance periphyton growth in Baron Fork and the Illinois River, and phytoplankton blooms and summer hypolimnetic anoxia in Lake Tenkiller.

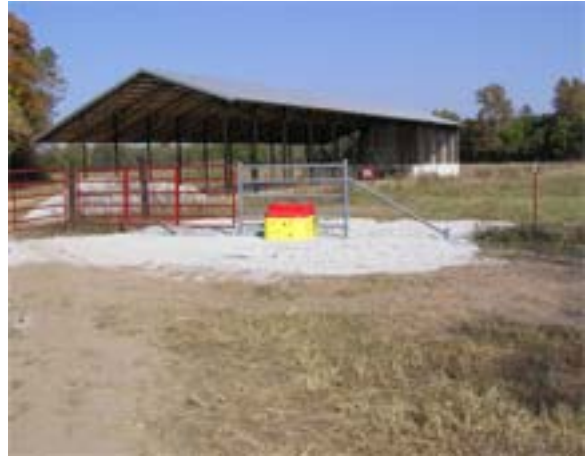
Figure 34.

Failure to install originally planned practices led to unobligated monies but a lack of willing landowners. Therefore, landowner needs were evaluated to come up with practices that would solve landowner problems and protect water quality. The solution was winter feeding areas (Figure 34). Through installation of these feeding areas, landowners had a facility to feed livestock in a healthier, less wasteful, more convenient area. At the same time, cattle were encouraged to concentrate in an area farther away from the stream where waste products could be collected and disposed of more appropriately.

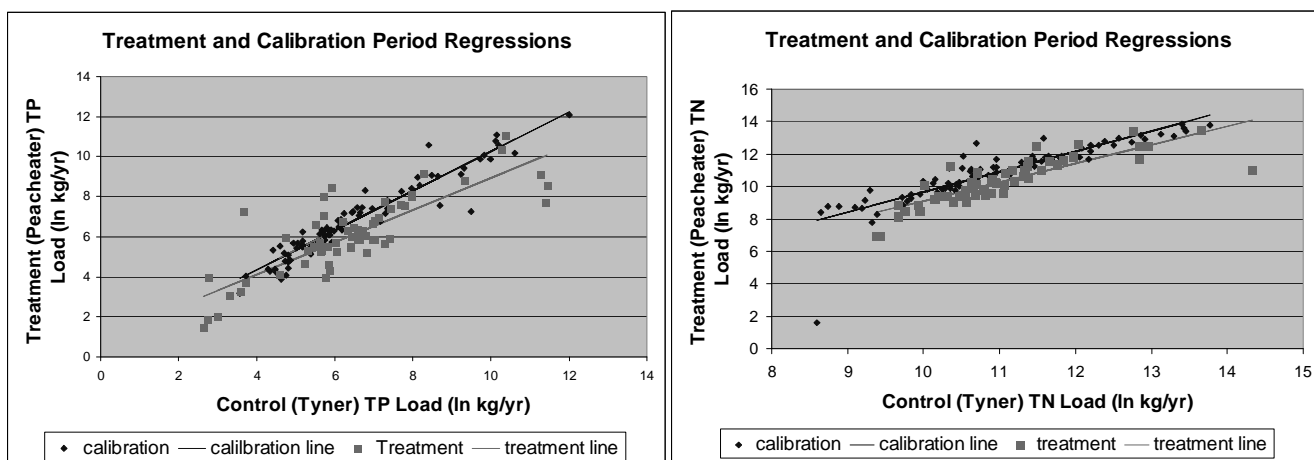
Two years of post-implementation monitoring began in 2003 in order to document water quality changes due to installation of best management practices. Analysis of results indicated statistically significant reductions in total phosphorus loading (66%) (Figure 35), total phosphorus concentration (10%), nitrate concentrations (23%), nitrite concentration (54%), and total nitrogen loading (57%) (Figure 36), due to the implementation of practices. Analysis also suggested a significant increase in dissolved oxygen concentrations (3%). Impacts of these water quality changes were more significant during baseflow conditions than highflow conditions.
